MODIFICATION TO PREVENT MICRO LOCKUP ON AR3000A

March 1992 - AOR UK Ltd.

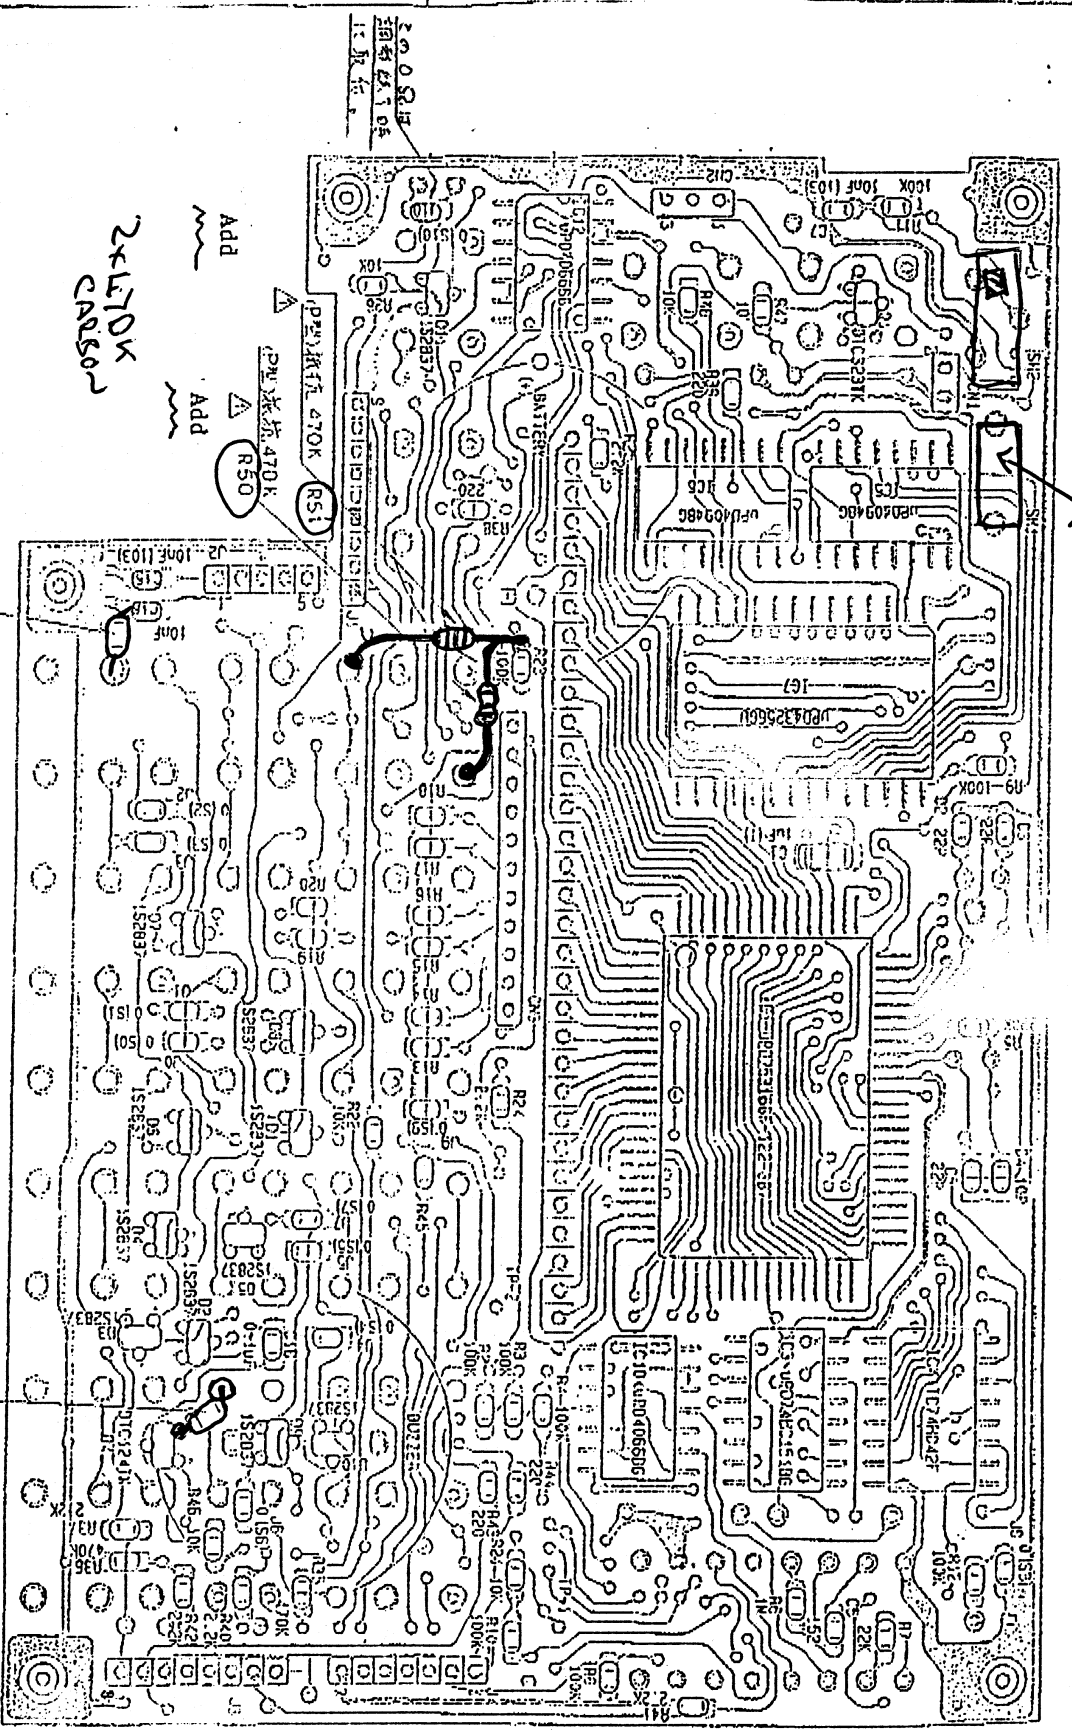
Modification for lock-up problem
MICO BOARD R23000A

Should you experience frequent microprocessor lockups on the AR3000A receiver due to microprocessor runaway, the following modification may be implemented:

- R50 Add a 470k carbon resistor to the point indicated on the accompanying PCB layout
- R51 Add a 470k carbon resistor to the point indicated on the accompanying PCB layout
- R49 Add a 470k chip resistor to the point indicated on the accompanying PCB layout
- R52 Add a 470k chip resistor to the point indicated on the accompanying PCB layout. You will first need to remove the black bleeder unit by de-soldering the two connections from the LCD side of the PCB.

These additions have now been incorporated into production.
